## VACANT WAREHOUSE FIRE

# **FIRE INVESTIGATION REPORT**

**Vacant Warehouse Fire  
One Fire Fighter Killed  
Seattle, Washington  
September 9, 1989**

**Prepared by  
Michael S. Isner  
Fire Protection Engineer  
Fire Investigations Division  
National Fire Protection Association**

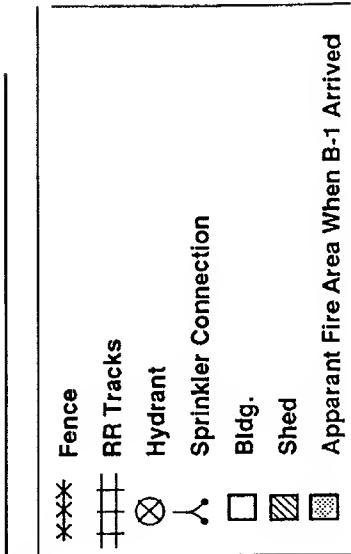
Figure 2

B-1 arrived on the scene at 9:23 p.m. before any other fire department units. He found a 75 ft X 75 ft shed adjacent to the southwest corner of the building completely involved in fire, and it appeared that the fire could have been extending into the building. (See Figure 2, Appendix B.)

1st Alarm and 1st Special Call  
Fire Company Placement

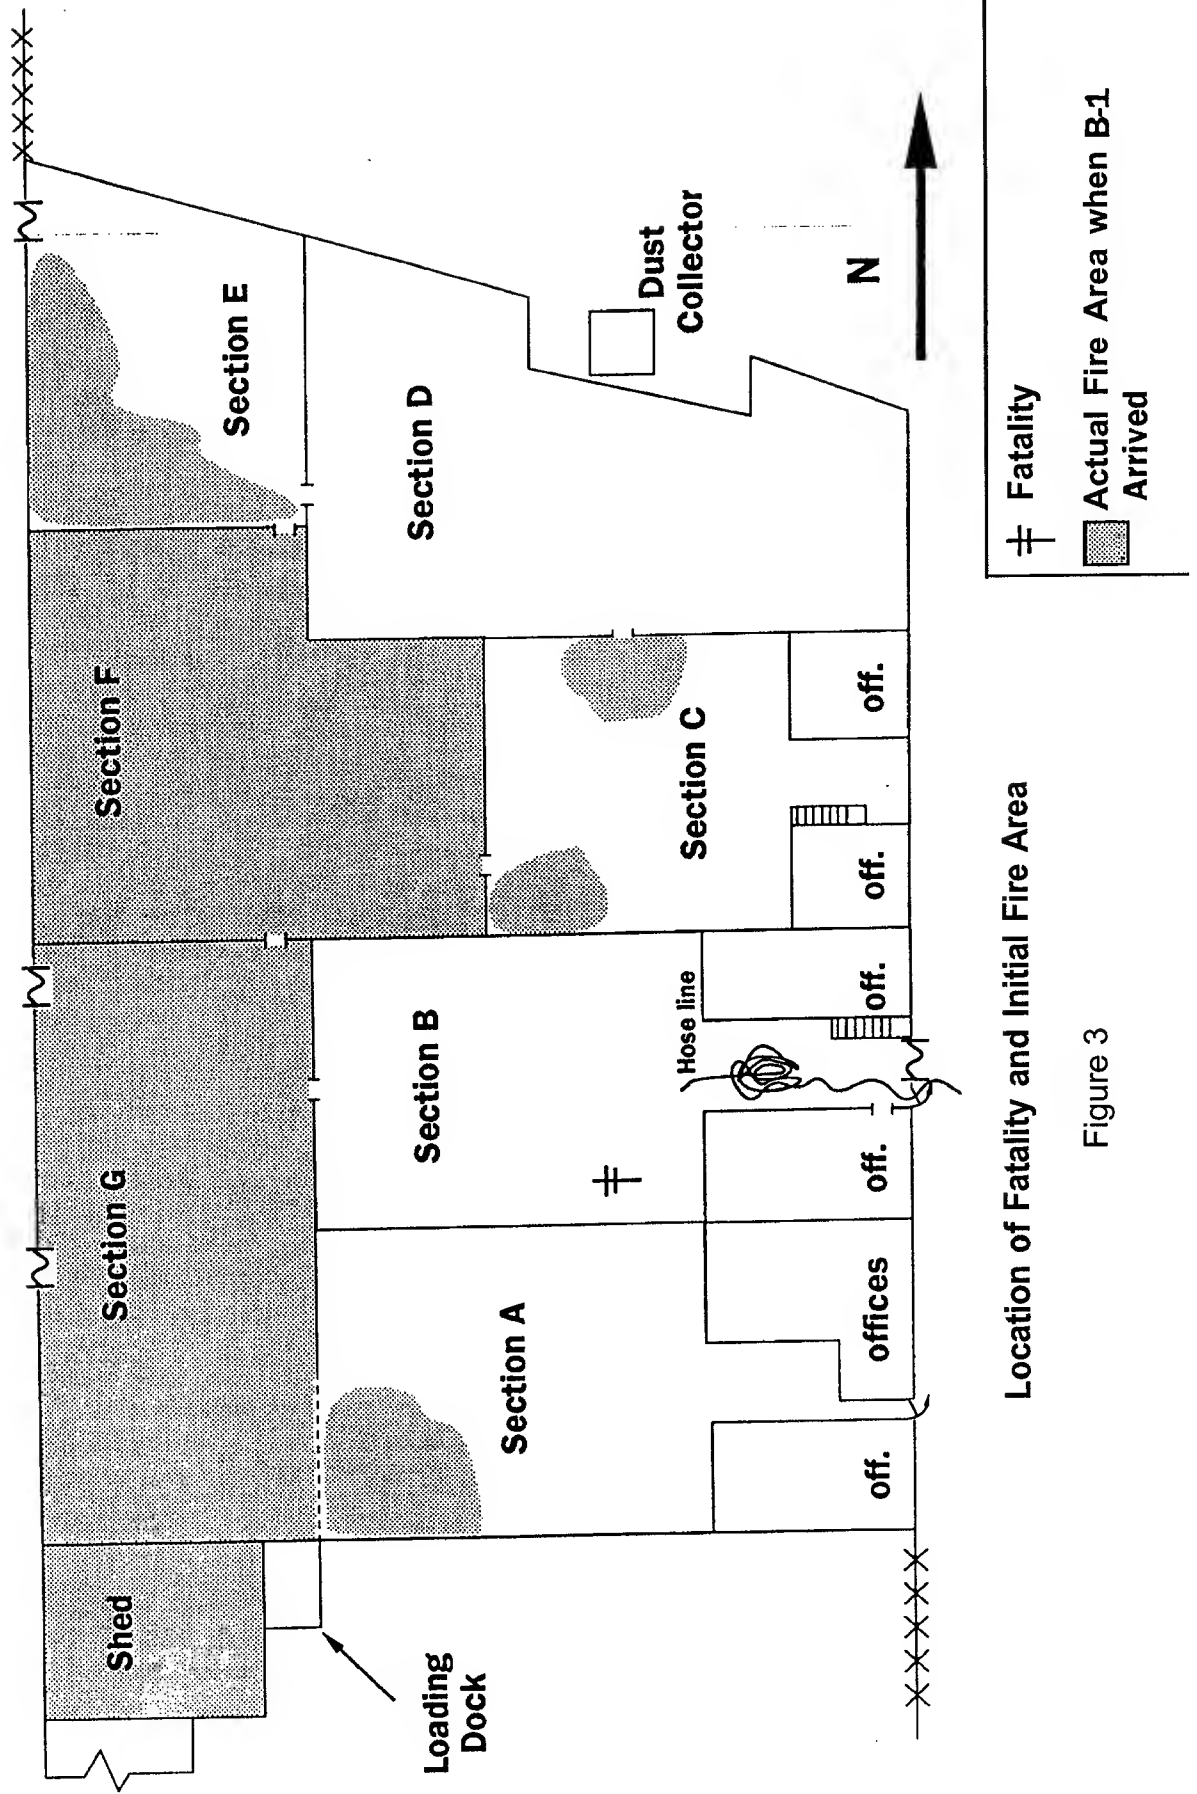
Figure 3

The missing officer was located in Section B, approximately 80 feet from the door he entered and under about two feet of debris. (See Figure 3, Appendix B.) The search took about one hour, and the officer was dead at the time of discovery.

Location of Fatality and Initial Fire Area
